RESIN

MINI PROJECT BROCHURE

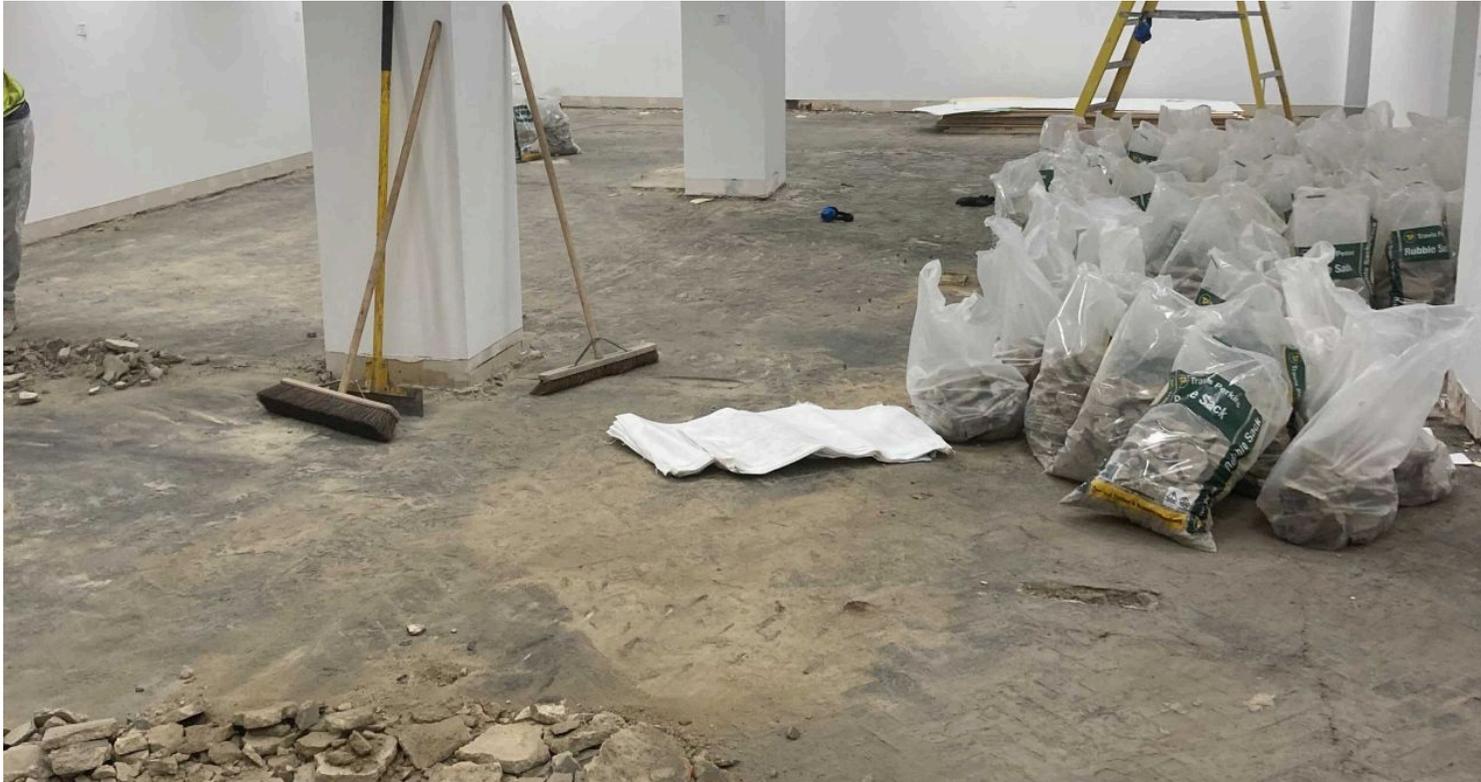
ART GALLERY - LONDON

Summary: Removed loose screed and repaired the substrate, reinforcing cracks within the concrete slab. A water-based mid-grey epoxy coating was then applied, delivering a smooth, durable finish with improved structural integrity.

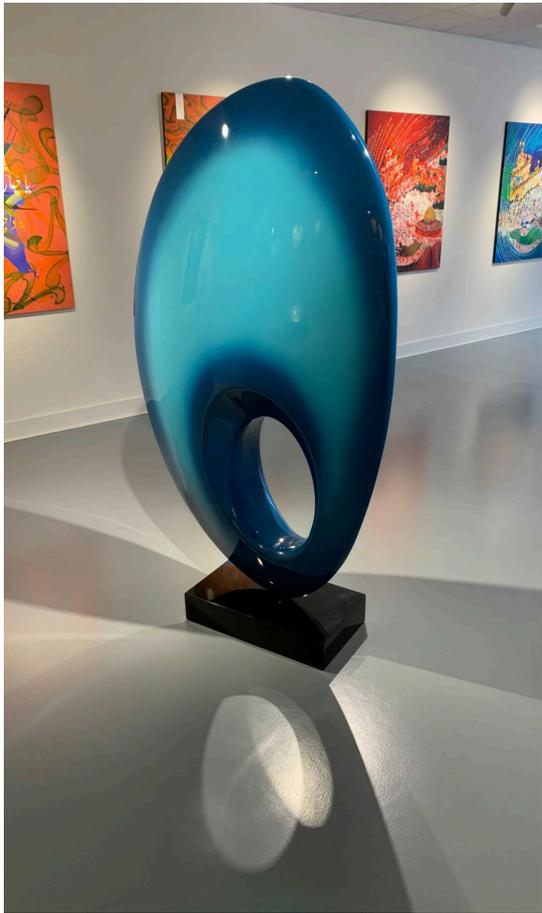
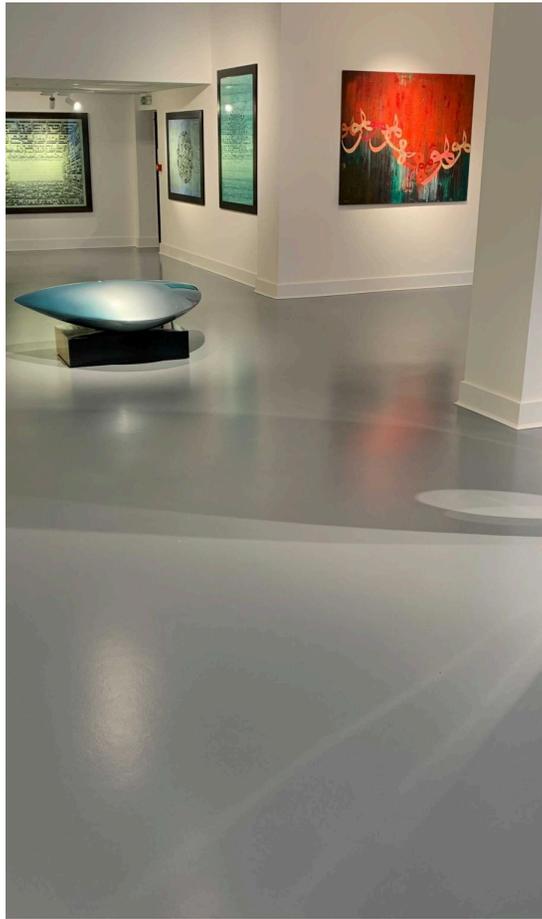
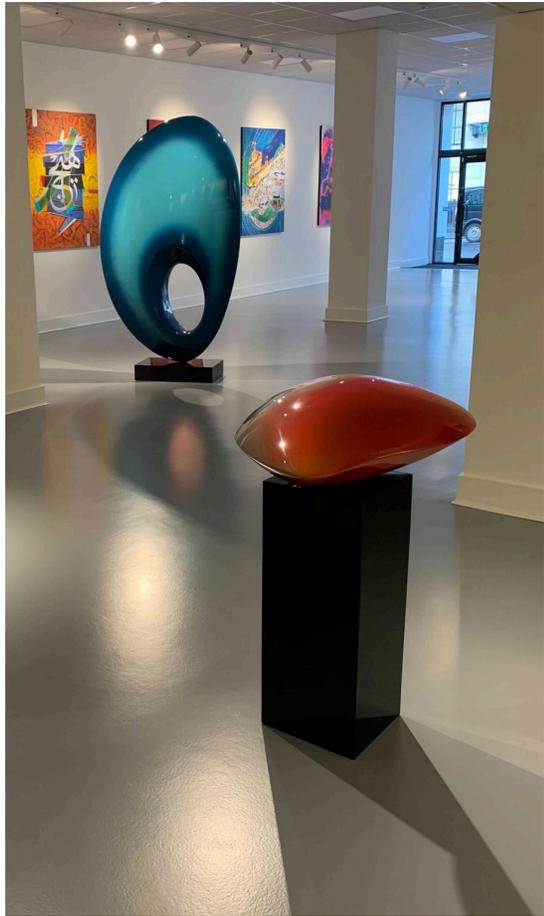
MOLTON BROWN

Scope: Diamond grinding of existing concrete floor. Self-leveling epoxy flooring system & coving

Summary: Installed a high-performance epoxy floor capable of withstanding heavy use, chemical exposure, and frequent cleaning. Despite multiple trades on site, careful planning ensured smooth delivery. The project was completed on time, within budget, and finished with a durable, seamless floor.

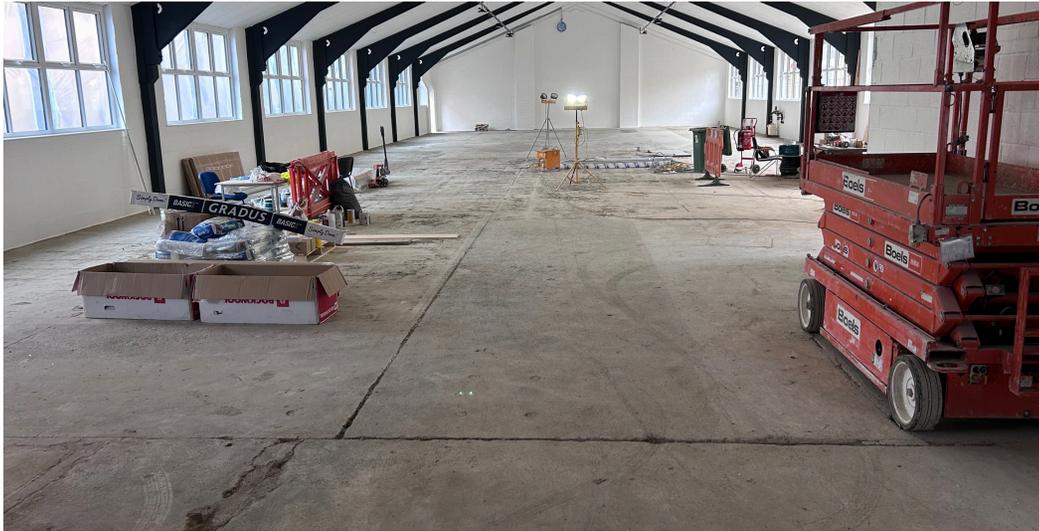
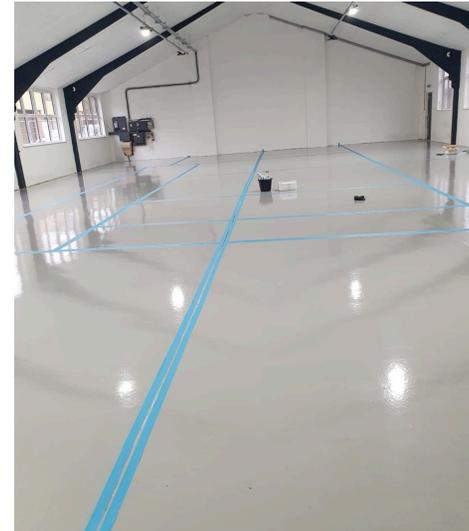
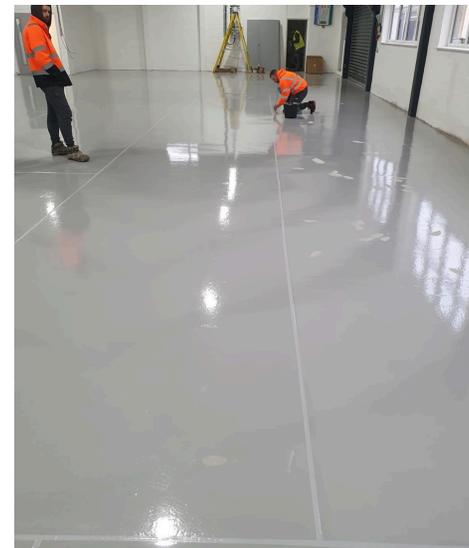
BOYN VALLEY WAREHOUSE - READING

Summary: Existing epoxy SL was removed using aggressive PCD diamond grinding. Localised concrete repairs were carried out to remediate the slab before full regrinding. The floor was then recoated with Flowercrete SF41. Expansion joints were saw-cut and resealed using a suitable jointing mastic to complete the system

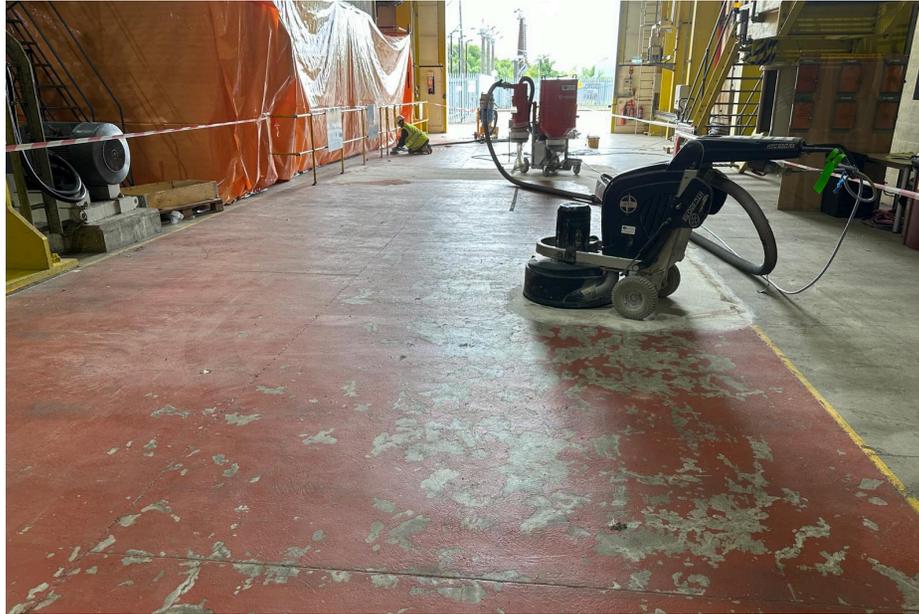
HODDESON POWER STATION

Summary: Ground the existing floor to remove the failing resin coating and expose a smooth concrete slab. Applied two coats of high-build epoxy, reinstated joints, and installed yellow line marking, delivering a durable, compliant finish suitable for a power station environment.

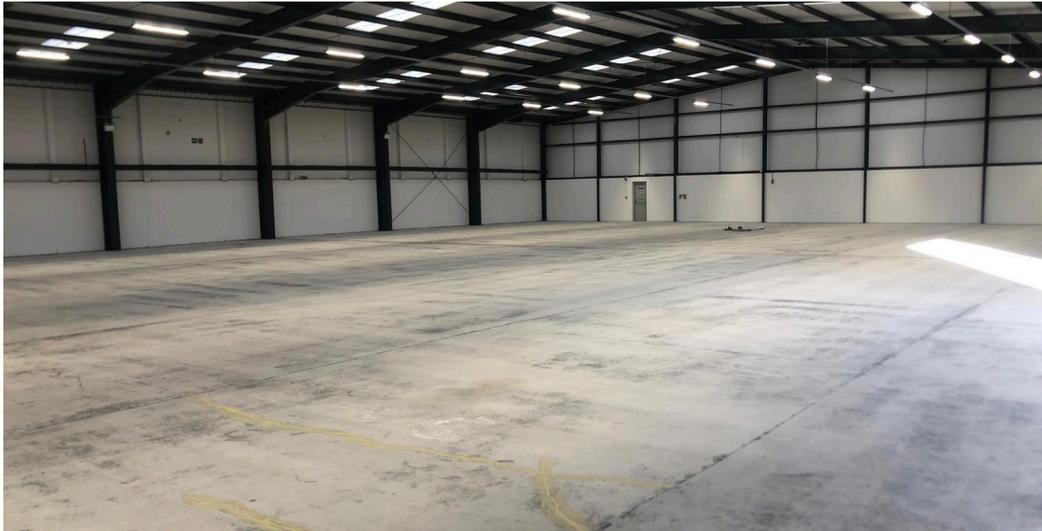
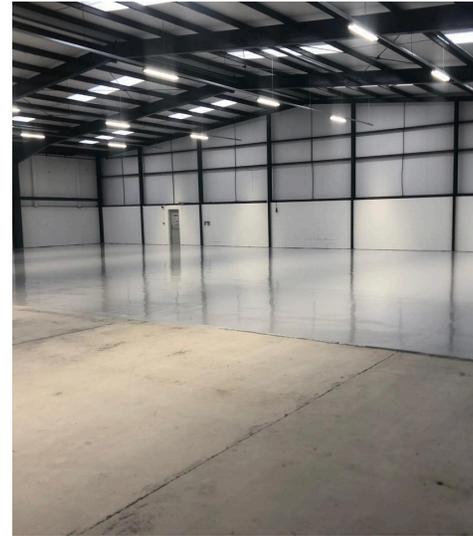
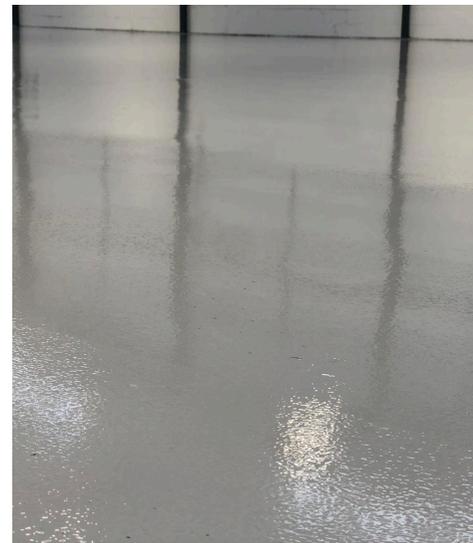
DAB GROUP - IPSWICH

Summary: Removed existing line markings, ground back exposed aggregate, and applied epoxy scratch coats where required. Installed a two-pack deep-fill filler, diamond-sanded for a smooth finish, then applied a high-build epoxy topcoat for a durable, seamless result.

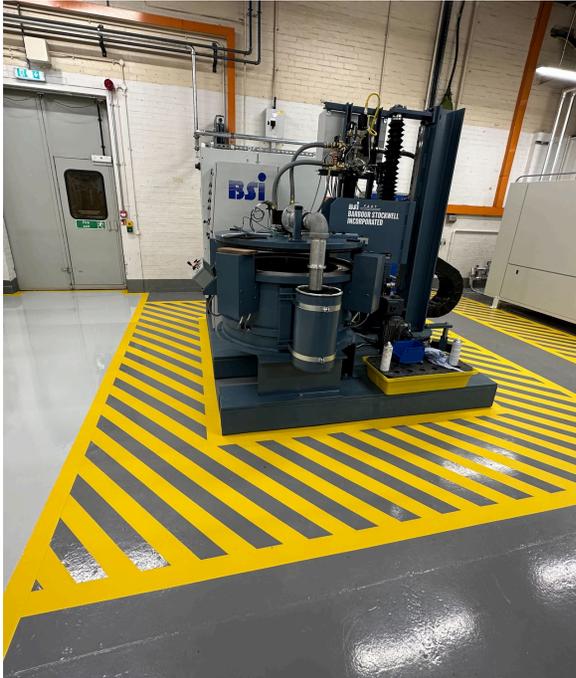
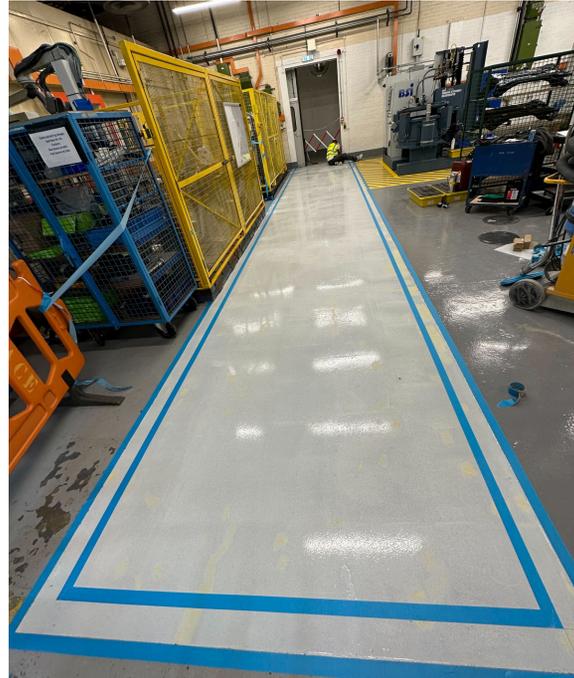
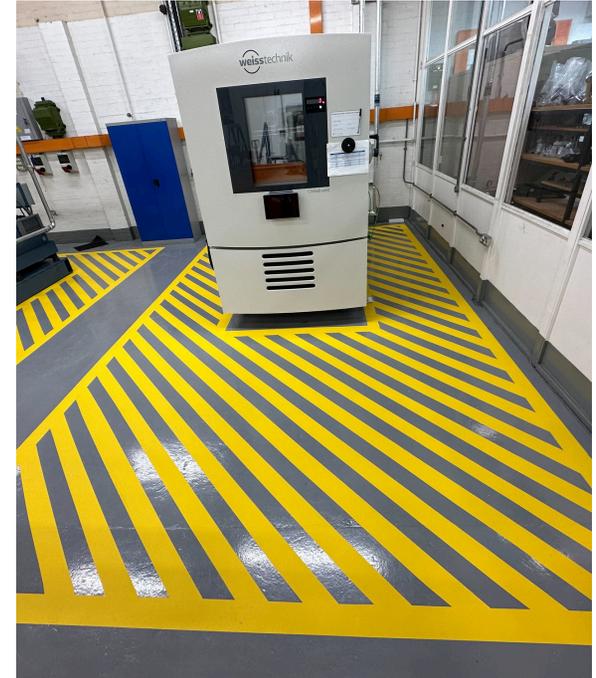
LINE MARKING IN FORDS DUNTON

Summary: Removed the flaky existing coating and prepared the substrate before applying a new durable system. Reinstated clear, compliant line marking to create a safe, well-defined work area around new machinery.

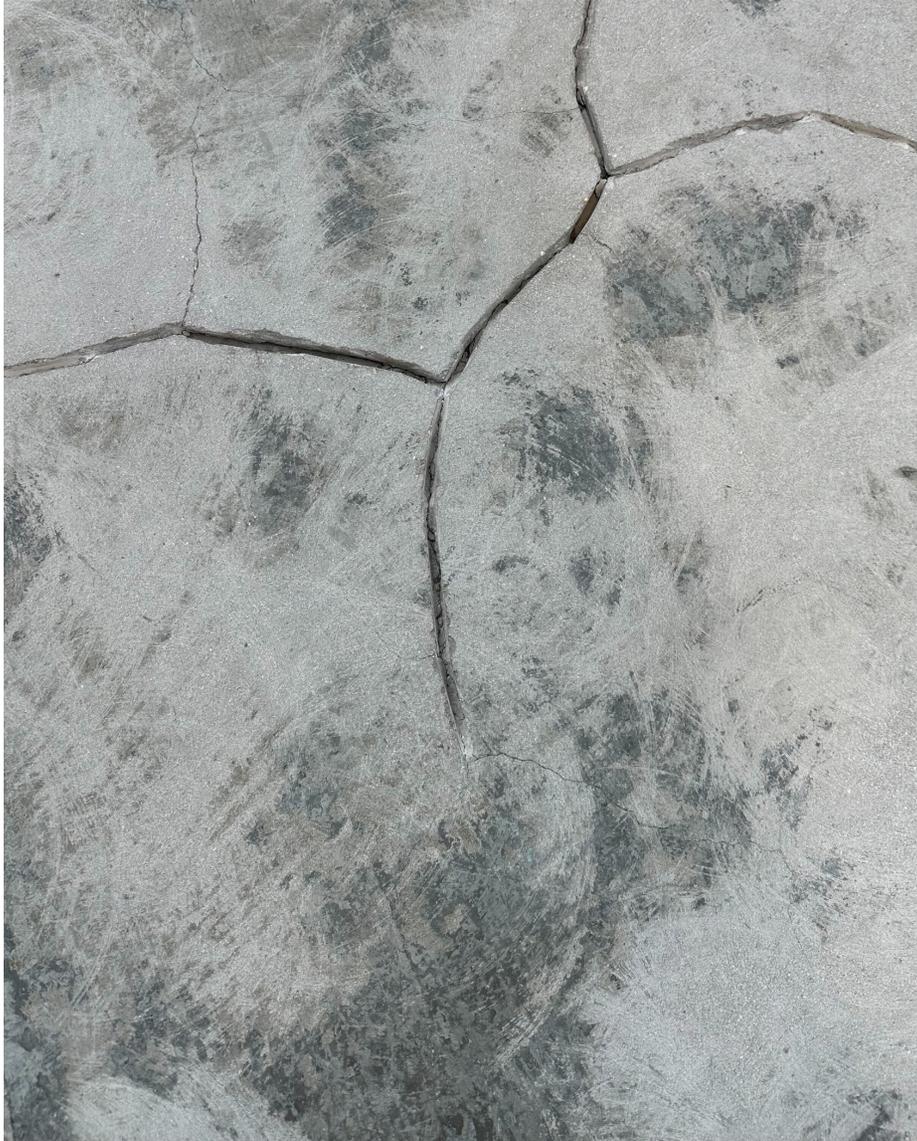
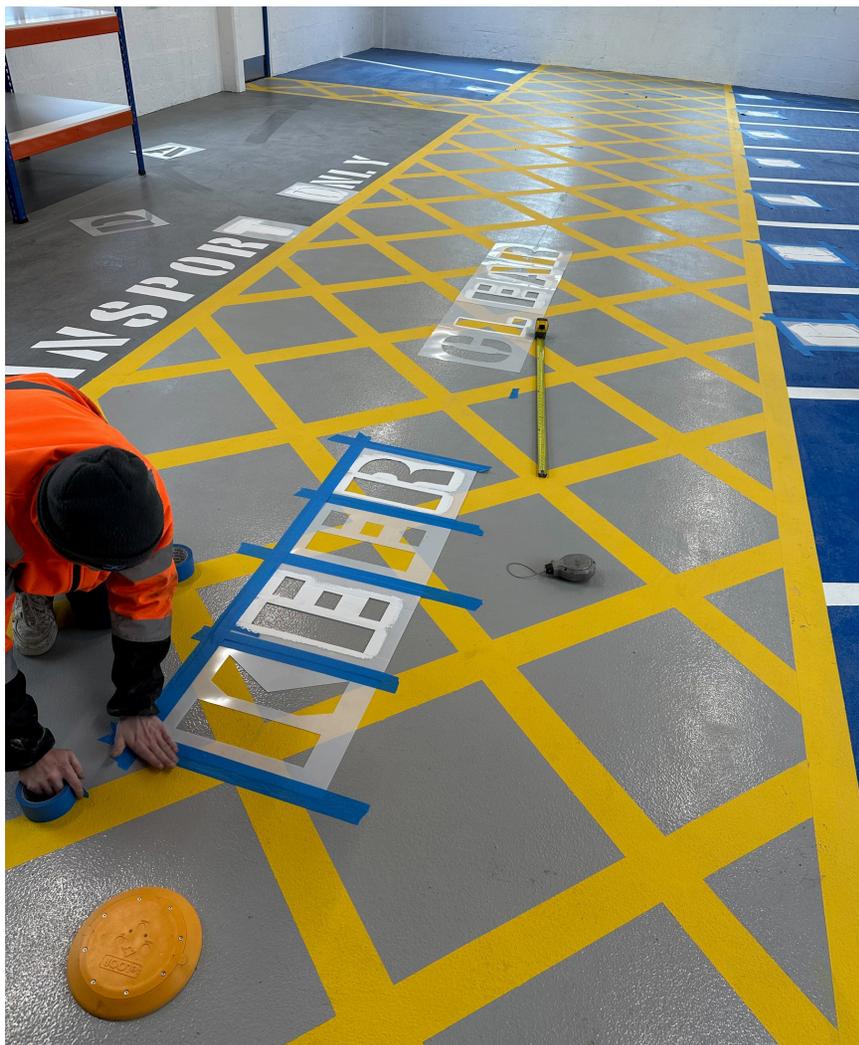
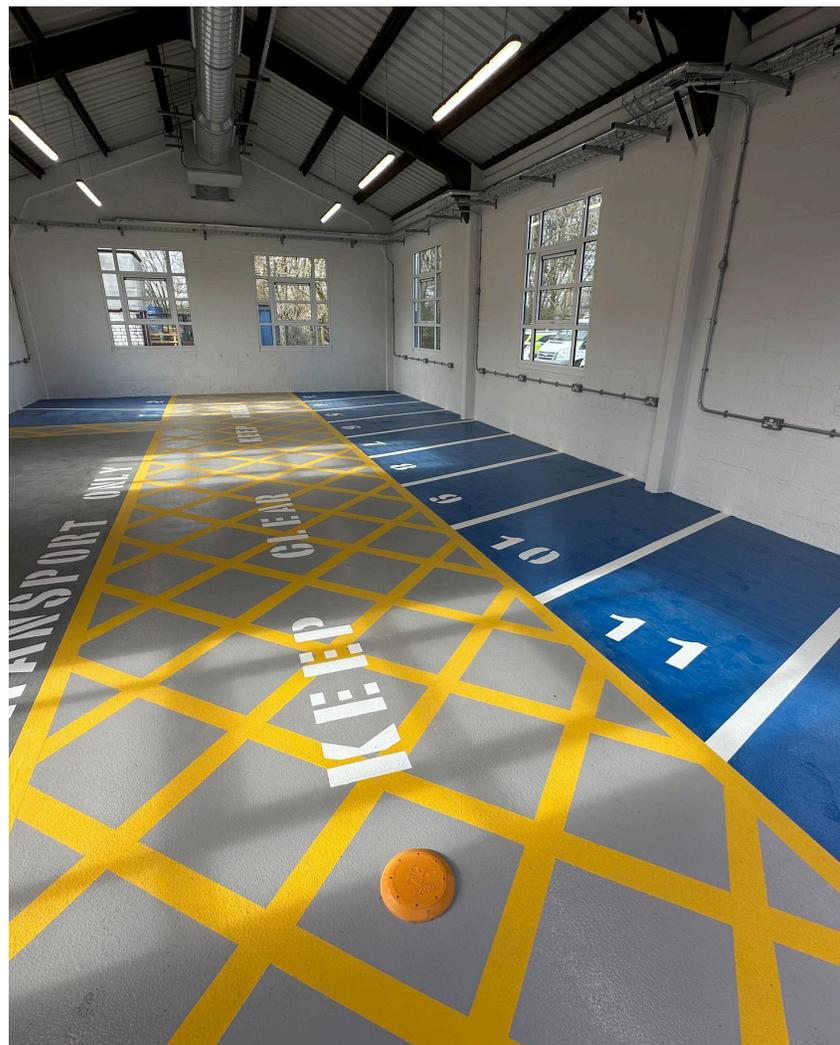
BOREHAM BIKE CLUB

Scope: Floor repairs, anti-slip treatment,
and line-marked bays

Summary: Refreshed and repaired the
centre's flooring, fixing blown screed and
sealing cracks with epoxy, added anti-slip
resin and line-marked bays. Despite
unexpected substrate issues, careful
planning kept the job on track and
delivered a flat, durable, and attractive
floor.
